**Kuskokwim River Middle Mile Fiber Technical Feasibility Study  
RD-RU-COOP-25-09**

**Cable Landing Sites Field Report**

Prepared for:  
United States Department of Agriculture  
Rural Utility Service

Prepared by:  
Ayers Telecom Consulting, LLC  
Anchorage, Alaska

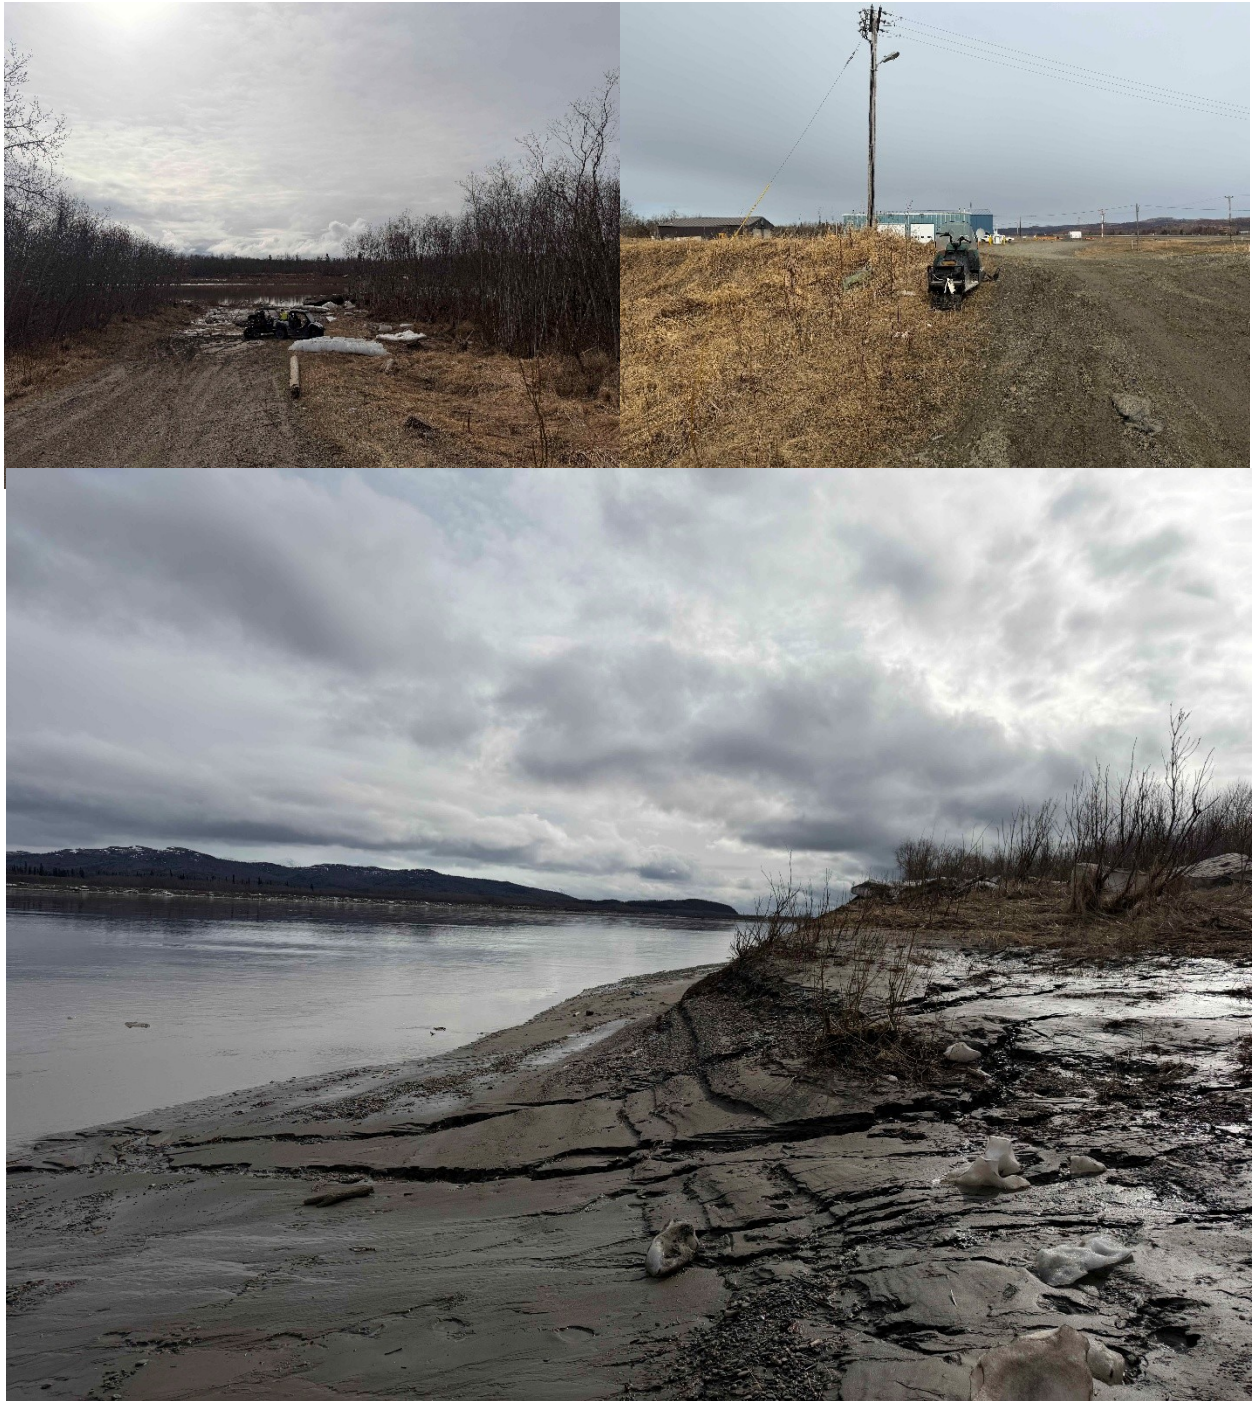
Figure B3. Aniak Site 2 Photos

| HDD BEACH APPROACH SITE GRADING FORM | | |
|---|---|---|
| Beach width / available work area | 2 | Area above high water was significantly smaller than google earth imagery. High water cam all the way up to the treeline |
| Bank stability / erosion risk | 3 | Erosion evident |
| Evidence of seasonal flooding / ice scour | 3 | Significant ice damage |
| Soil type suitable for HDD | 4 | Soil and Loamy consisten with freshly eroded land, and slough. Low gravel content observed |
| Bore length reasonable | 3 | 400' Long bank would be exposed at low water. Need to extend bore into the deepest part of the slough |
| Unstable bank | <input checked="" type="checkbox"/> | Significant erosion observed |
| Ice scour zone | <input checked="" type="checkbox"/> | Potential |

| HDD BEACH APPROACH SITE GRADING FORM | | |
|---|---|---|
| Seasonal water level concern | <input checked="" type="checkbox"/> | Recommend late spring before boring |
| Engineered bore profile and Soundings recommended | | |

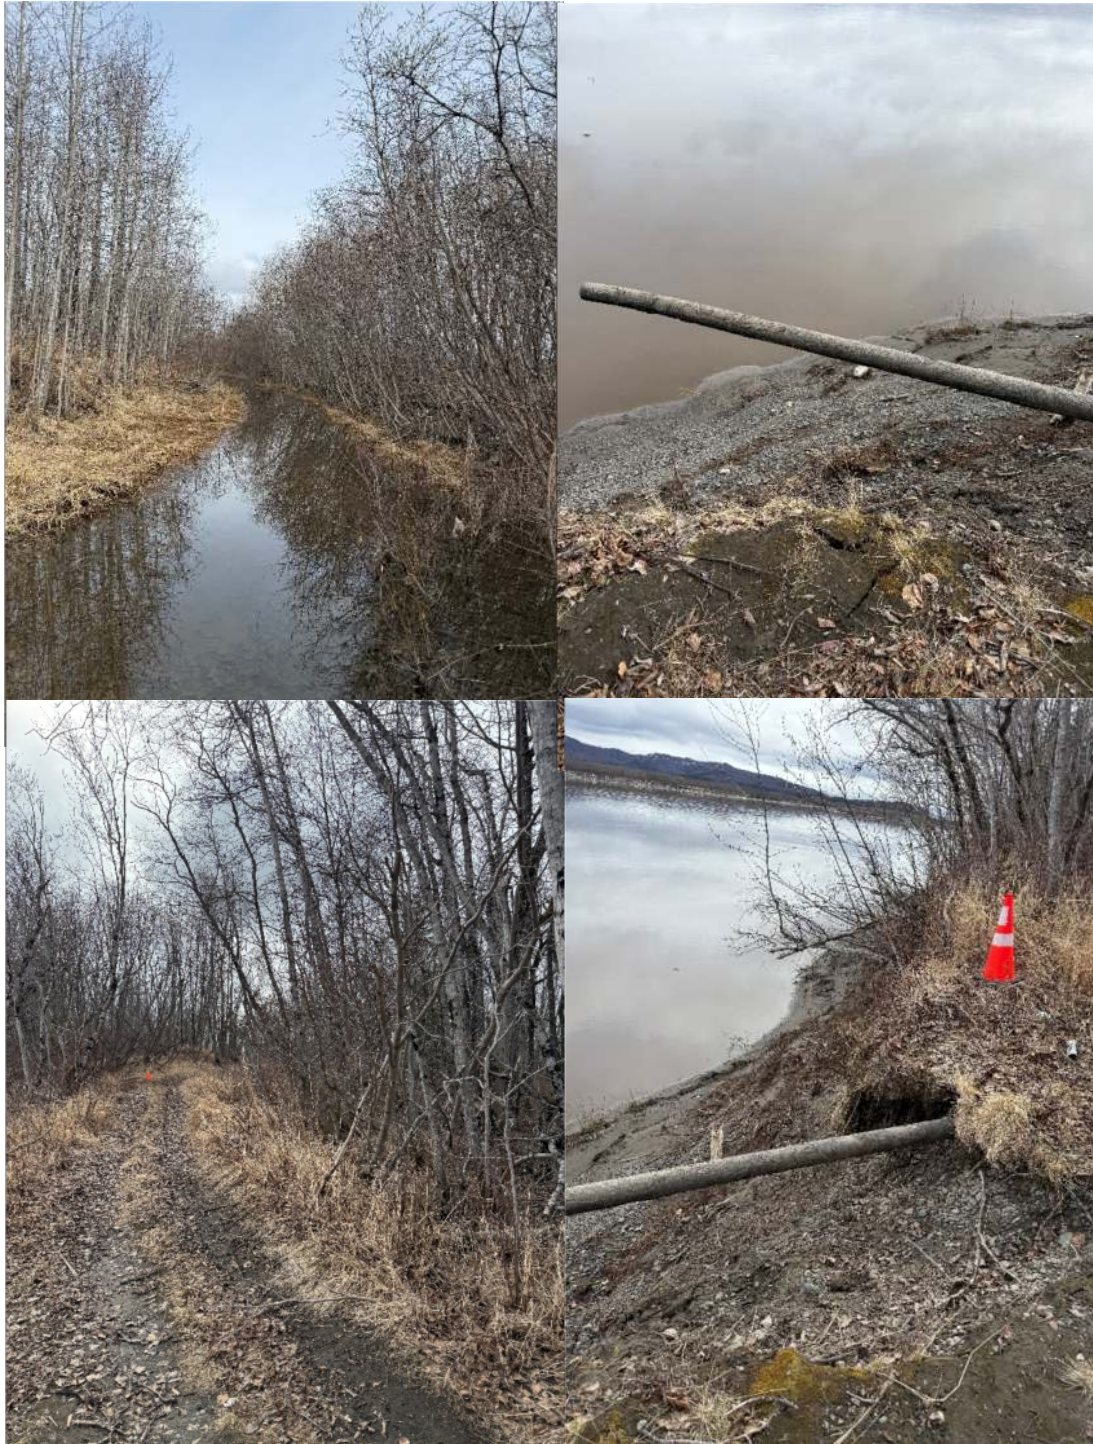
Figure C3. Aniak Site 3 Photos

| HDD BEACH APPROACH SITE GRADING FORM | | |
|---|---|---|
| Beach width / available work area | 3 | Area Workable would require clearing for proper set up |
| Slope from upland to river | 4 | Dike is steep but manageable |
| Bank stability / erosion risk | 4 | Dike appears intact with old growth trees on it |
| Cobbles / boulders / bedrock risk | 4 | Area is artificially raised so potential for fill materials to containg boulders. |
| Bore length reasonable | 4 | 290' channel runs close to the bank. More of the bore would be on shore to be well behind/Below dike. |

| HDD BEACH APPROACH SITE GRADING FORM | | |
|---|---|---|
| Seasonal water level concern | <input checked="" type="checkbox"/> | Recommend late spring before boring |
| Engineered bore profile and Soundings recommended | | |

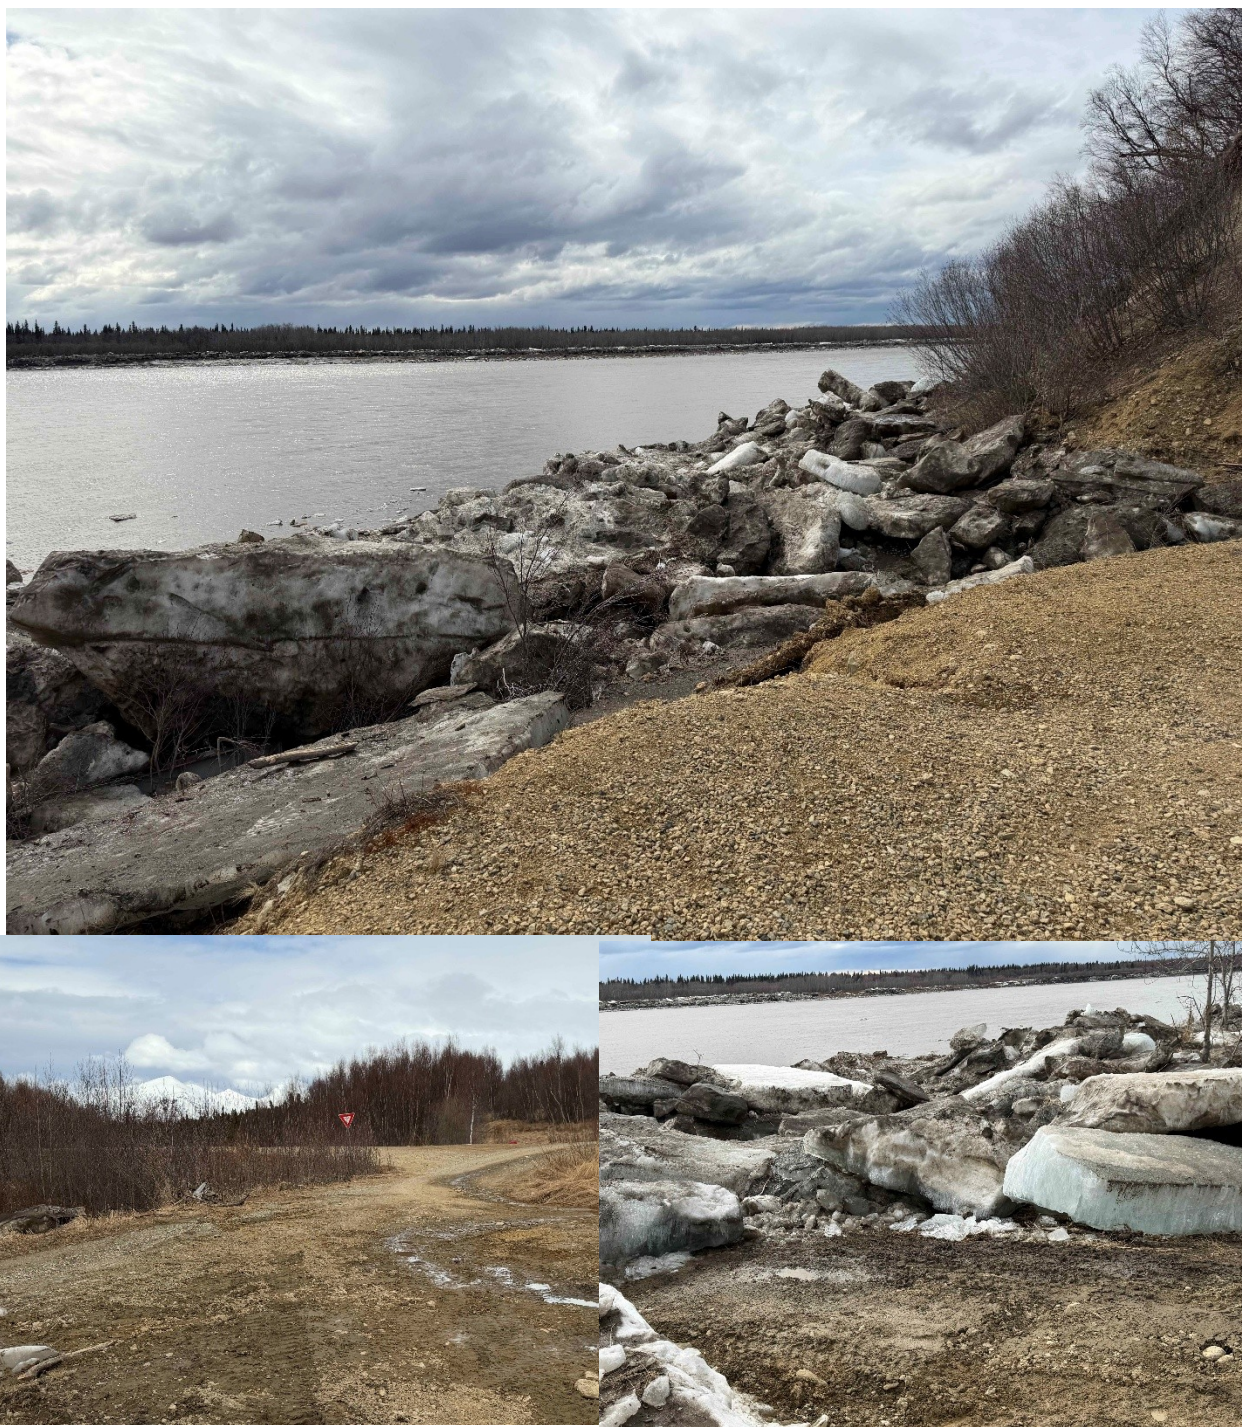
Figure D3. Chuathbaluk Site 1 Photos

| HDD BEACH APPROACH SITE GRADING FORM | | |
|---|---|---|
| Note Gravel pit potential Site rejected due to Distance from the village and extremely steep banks with erosion issues | | |

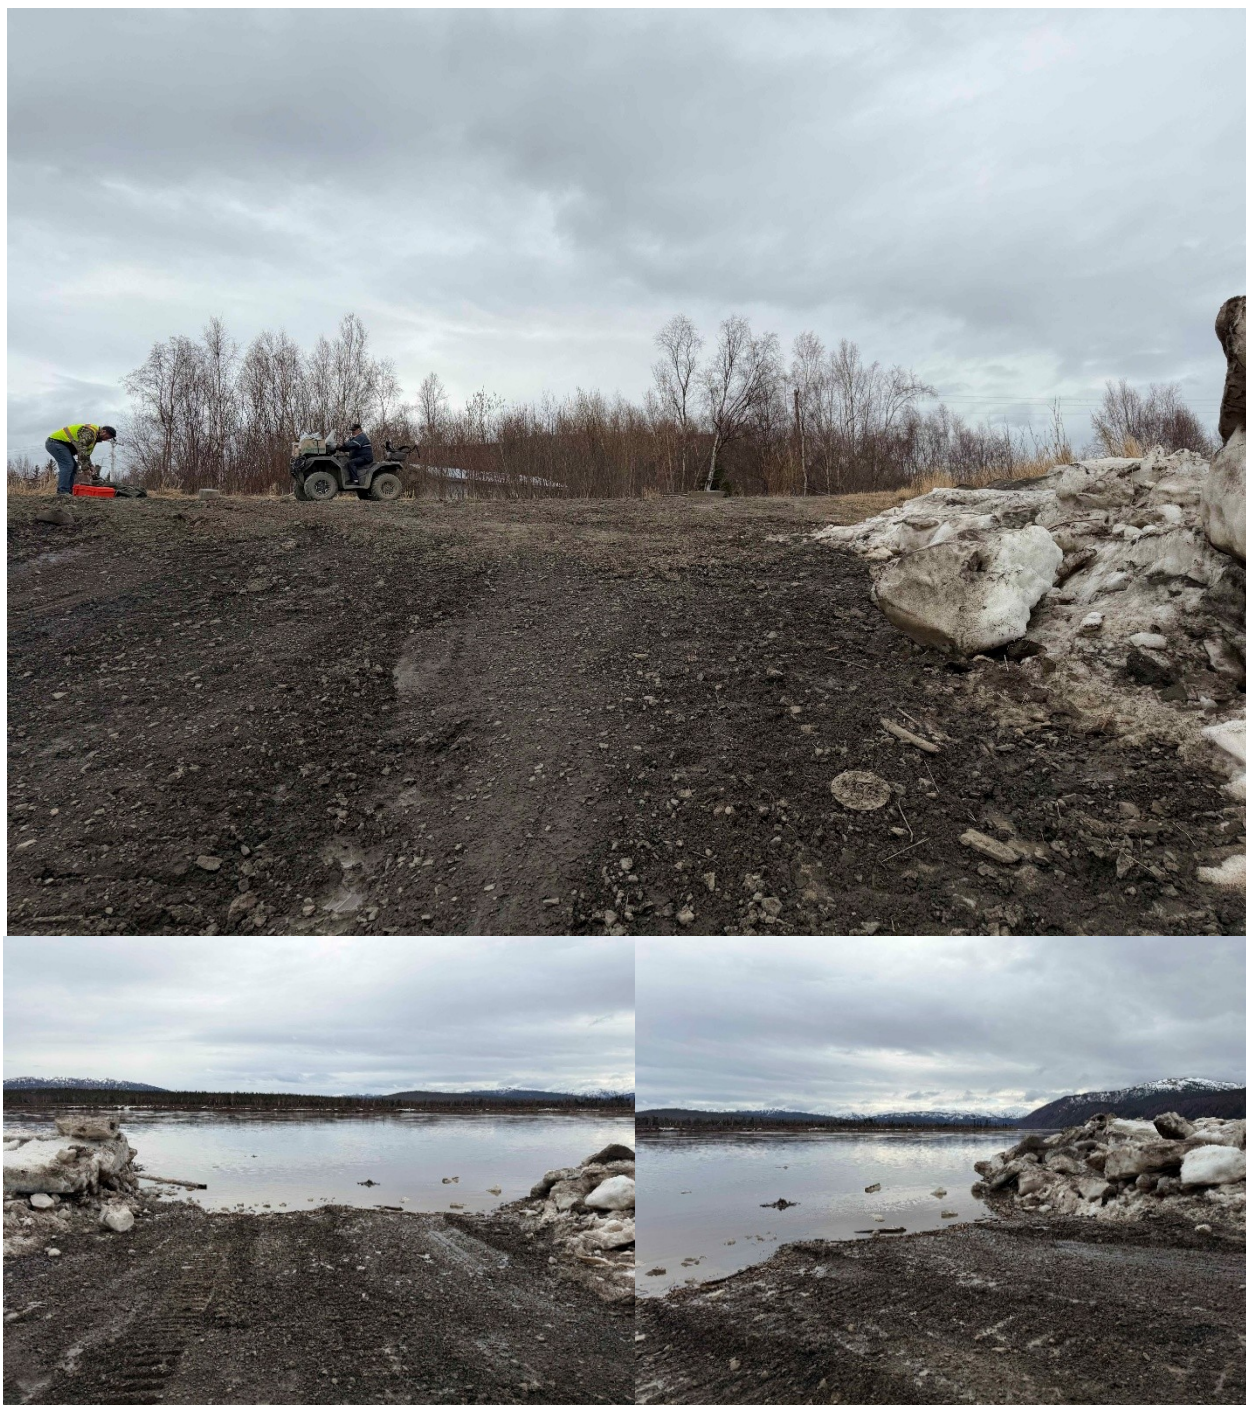
Figure E3. Crooked Creek Site 1 Photos

| HDD BEACH APPROACH SITE GRADING FORM | | |
|---|---|---|
| Soil type suitable for HDD | 3 | Ground conditions suggest Material consistent with River sediment and gravels. However, The greater area has a high likelihood of cobble and potentially rock. |
| Feasible HDD exit location below riverbed | 4 | Conditions unknown, Significant landed ice suggest river has a high volume and speed of flow. This may just be seasonal |

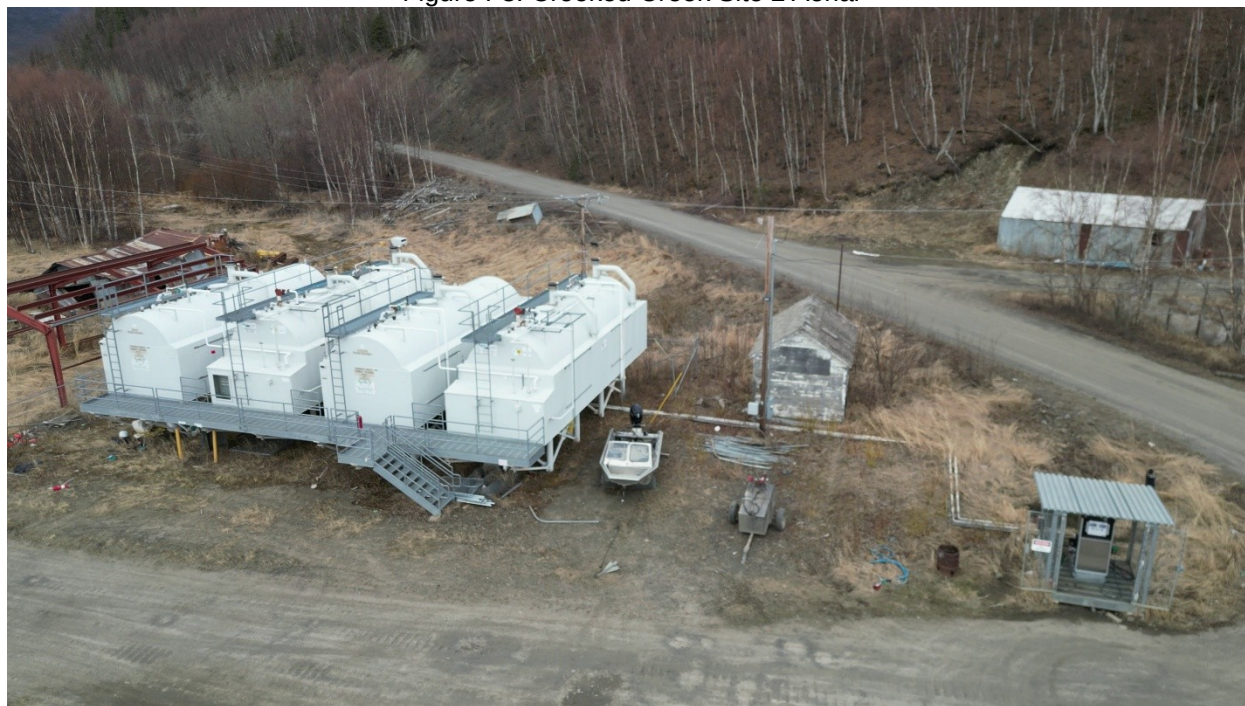
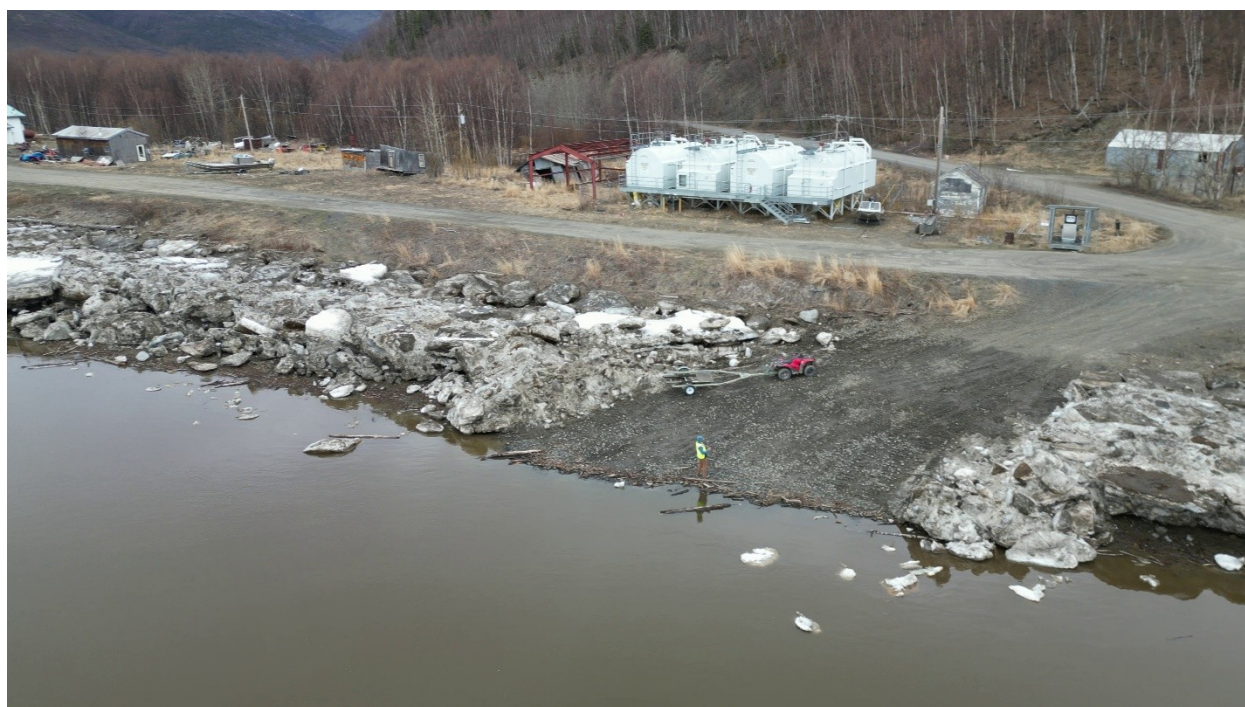
Figure F3. Crooked Creek Site 2 Aerial

| HDD BEACH APPROACH SITE GRADING FORM | | |
|---|---|---|
| Soil type suitable for HDD | 3 | Ground conditions suggest Material consistent with River sediment and gravels. However, The greater area has a high likelihood of cobble and potentially rock. |
| Feasible HDD exit location below riverbed | 4 | Conditions unknown, Significant landed ice suggest river has a high volume and speed of flow. This may just be seasonal |

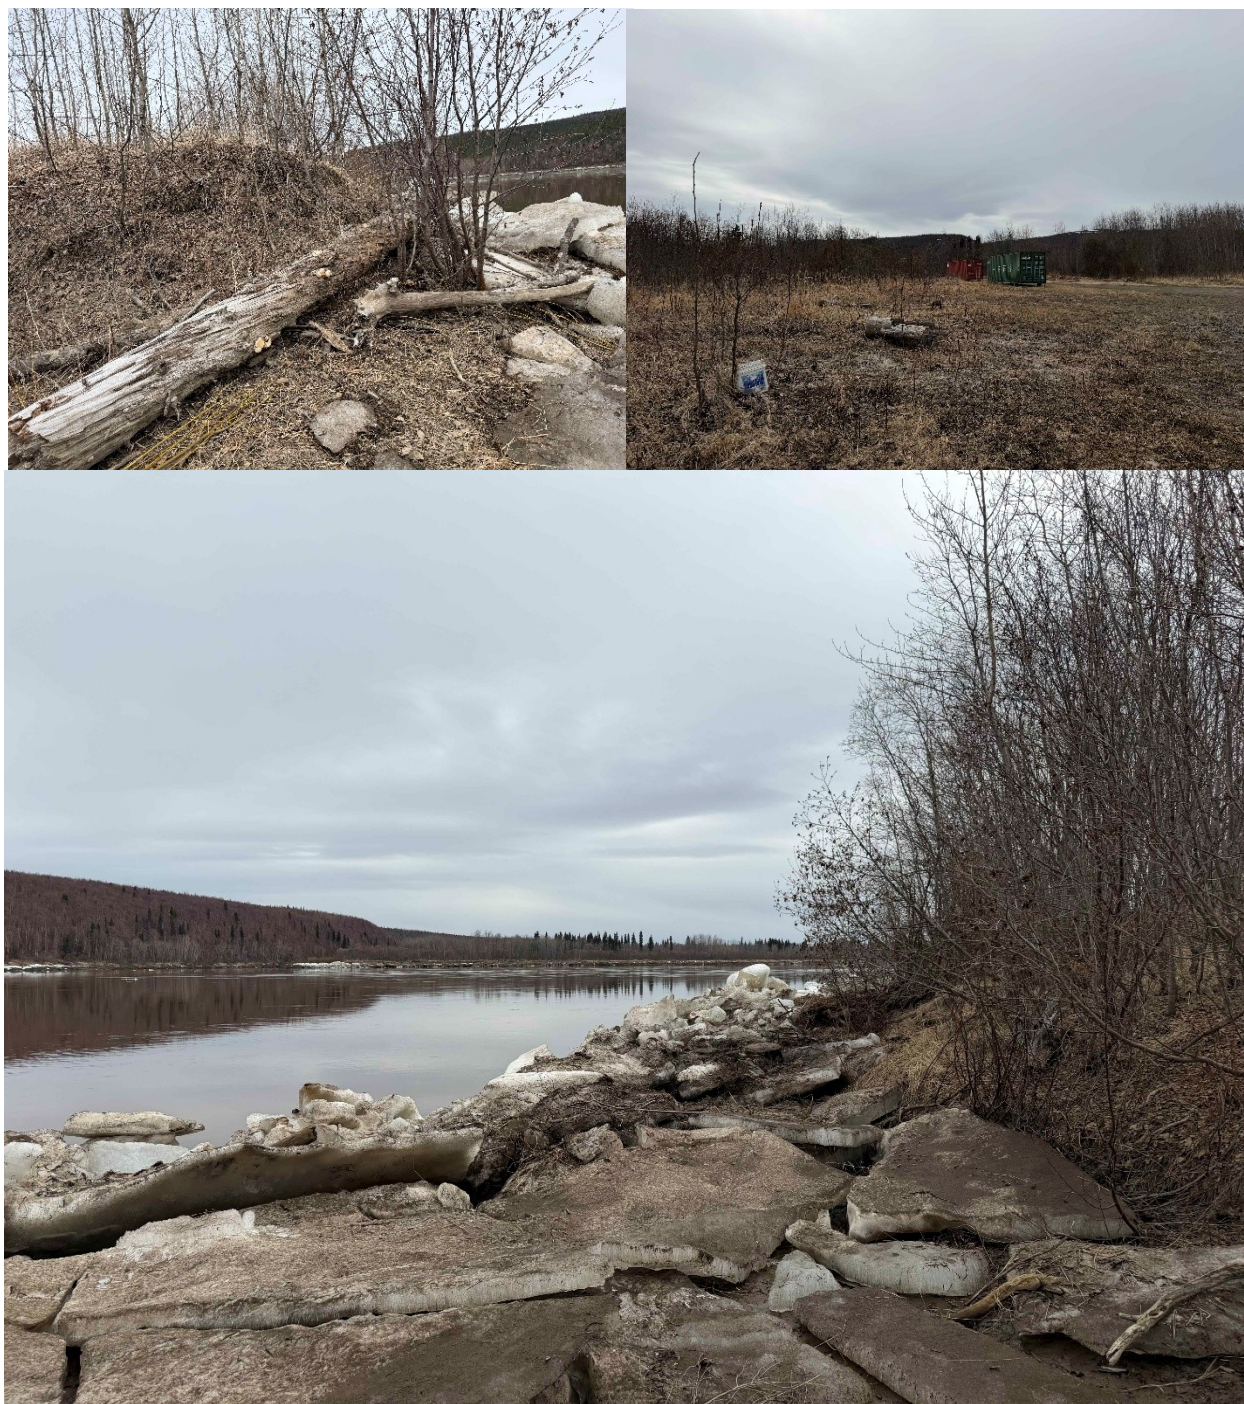
Figure G3. Red Devil Site 1 Photos

| HDD BEACH APPROACH SITE GRADING FORM | | |
|---|---|---|
| Cobbles / boulders / bedrock risk | 5 | None observed either on site or flyover |

| HDD BEACH APPROACH SITE GRADING FORM | | |
|---|---|---|
| Mud handling / containment area | 4 | Proximity to river and slope to beach/ recommendd BMPs |
| Distance to fiber hut / vault location | 3 | Due to active runway constraints recommend vault at beach with hut near first pole |
| Emergency response / safety access | 4 | Recommend local carrier on call |

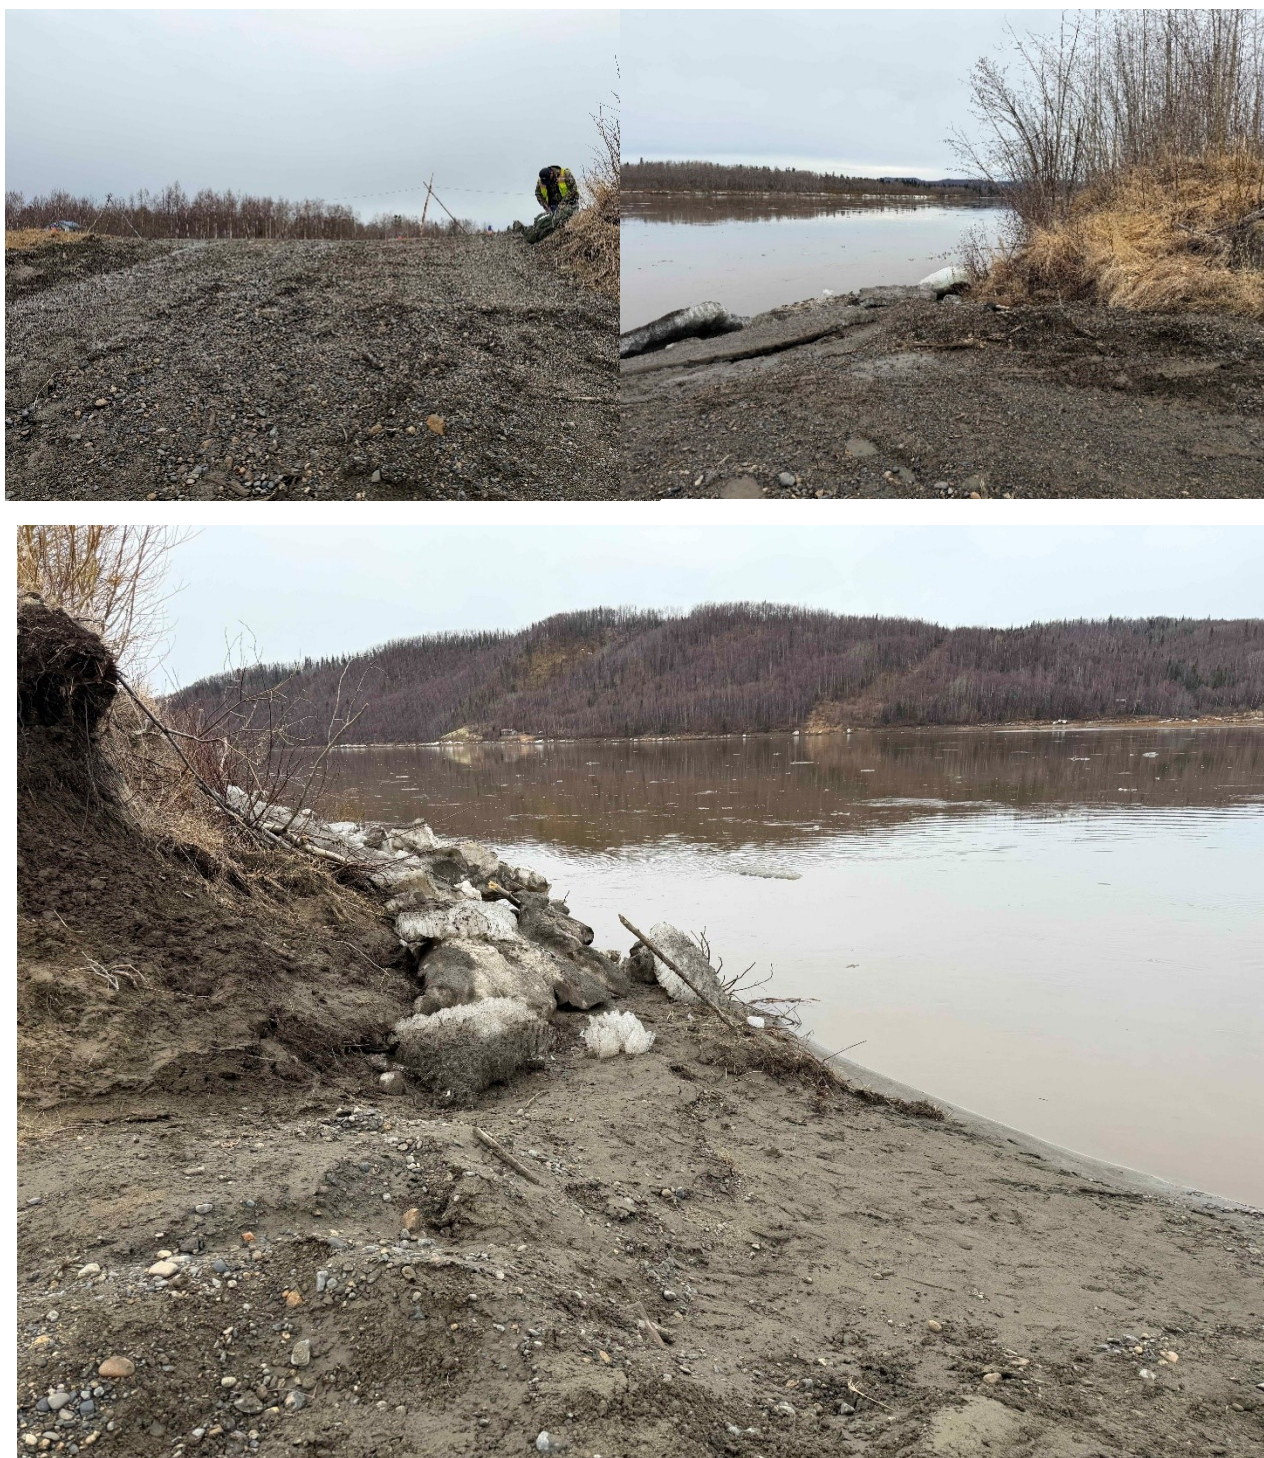
Figure H3. Sleetmute Site 1 Photos

| HDD BEACH APPROACH SITE GRADING FORM | | |
|---|---|---|
| Cobbles / boulders / bedrock risk | 4 | None observed |
| Distance to fiber hut / vault location | 2 | 500' plus to first pole. Hut site could be closer but recommend placement of the hut outside active quarry area |

| HDD BEACH APPROACH SITE GRADING FORM | | |
|---|---|---|
| Seasonal water level concern | <input checked="" type="checkbox"/> | Recommend mid to late summer due to high flow water |
| Recommended conduit size/count | | single 6" SDR11 HDPE Conduit (Recommend welded sticks not roll pipe) |

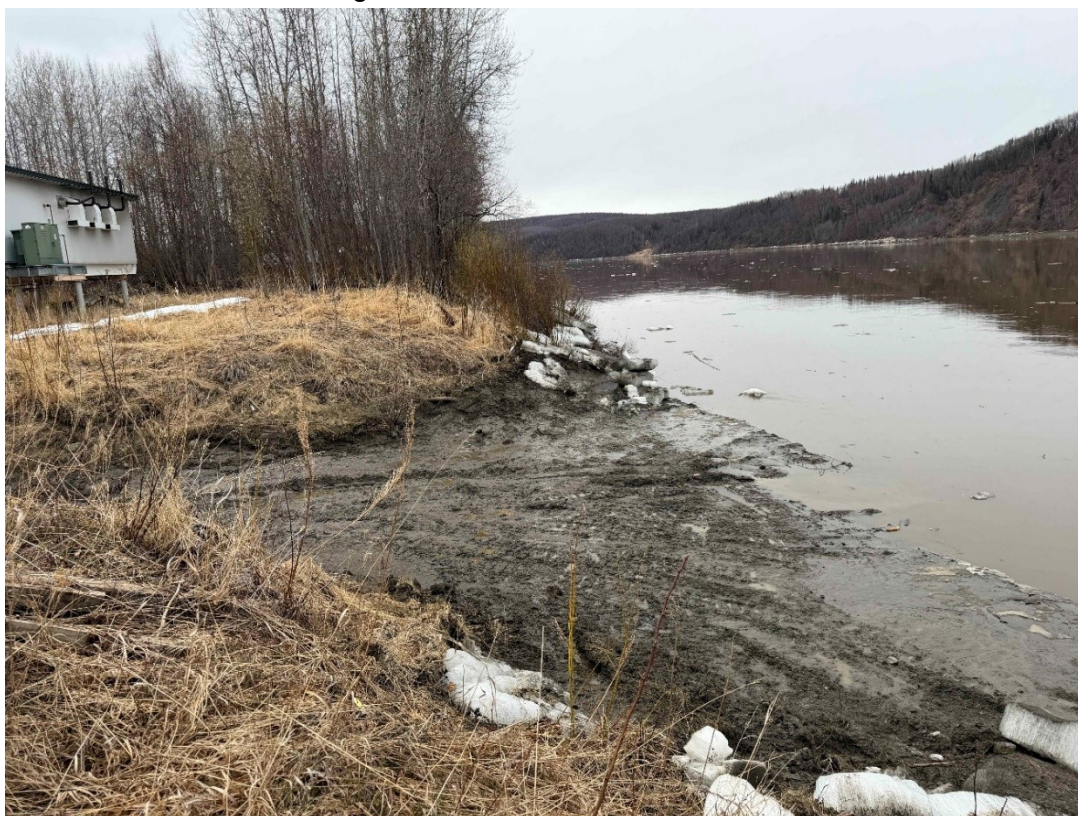
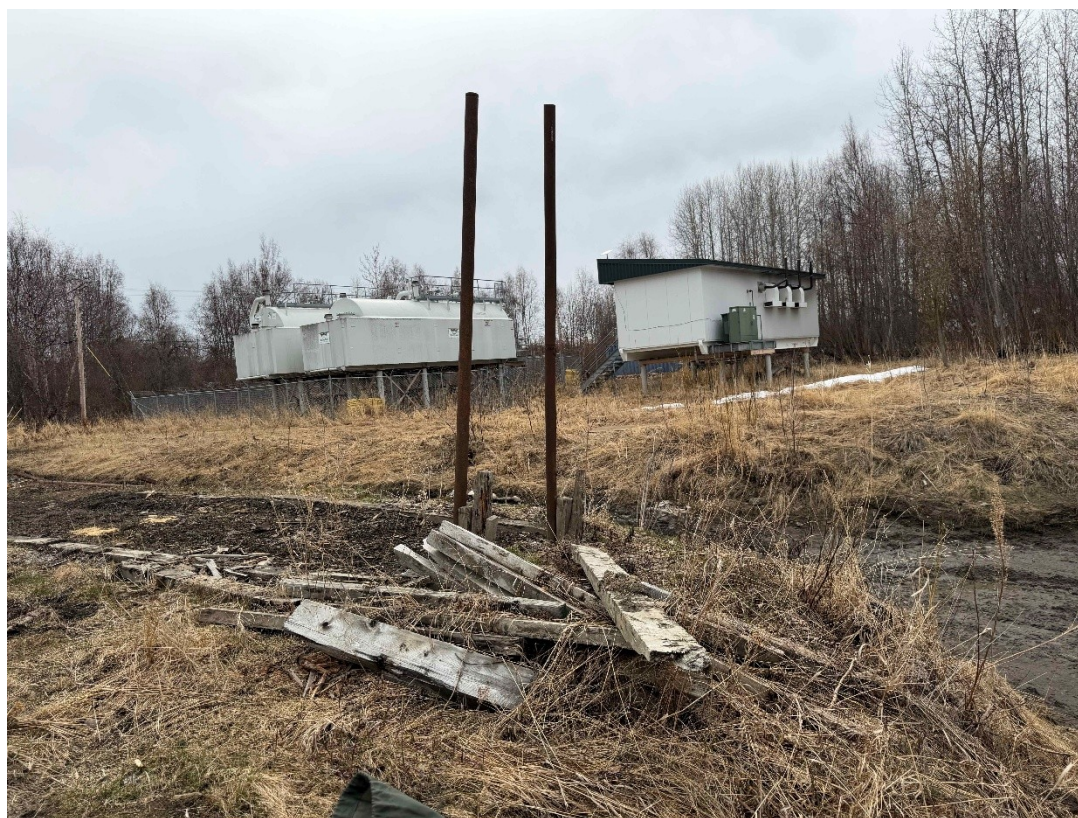
Figure I3. Sleetmute Site 2 Photos

| HDD BEACH APPROACH SITE GRADING FORM | | |
|---|---|---|
| Cobbles / boulders / bedrock risk | 4 | None observed |

| HDD BEACH APPROACH SITE GRADING FORM | | |
|---|---|---|
| Seasonal water level concern | <input type="checkbox"/> X | Recommend mid to late summer due to high flow water |
| Additional soundings and engineered bore path required | | |

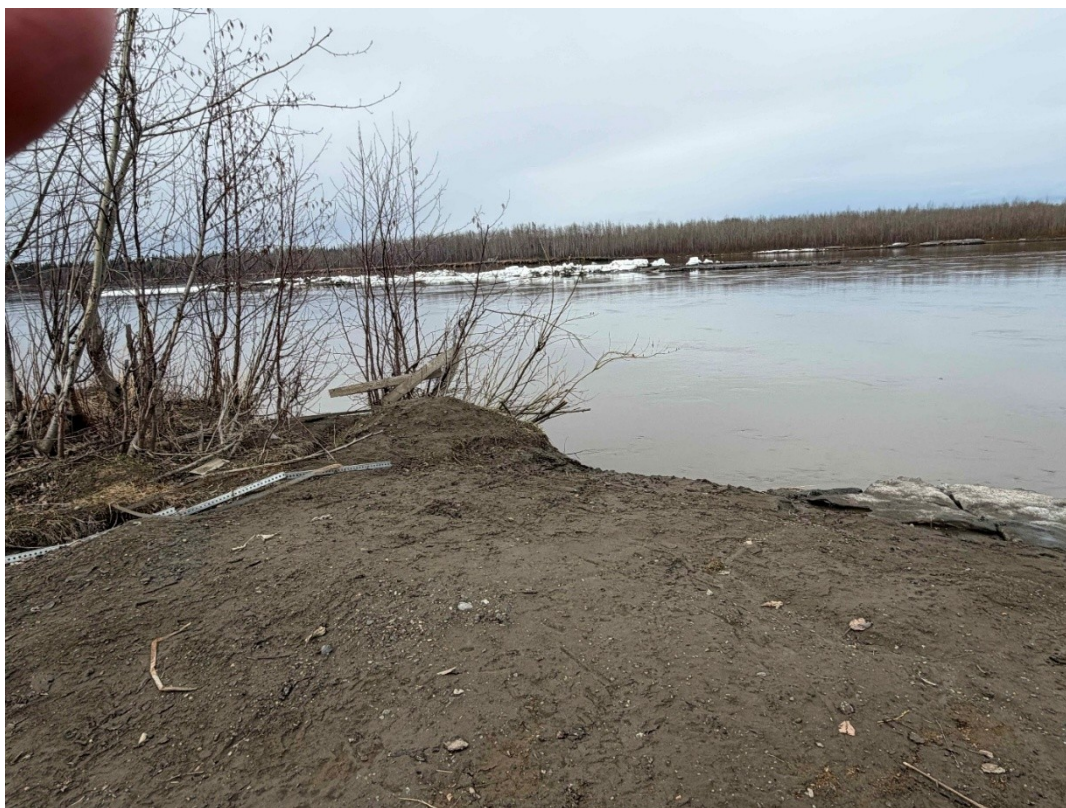
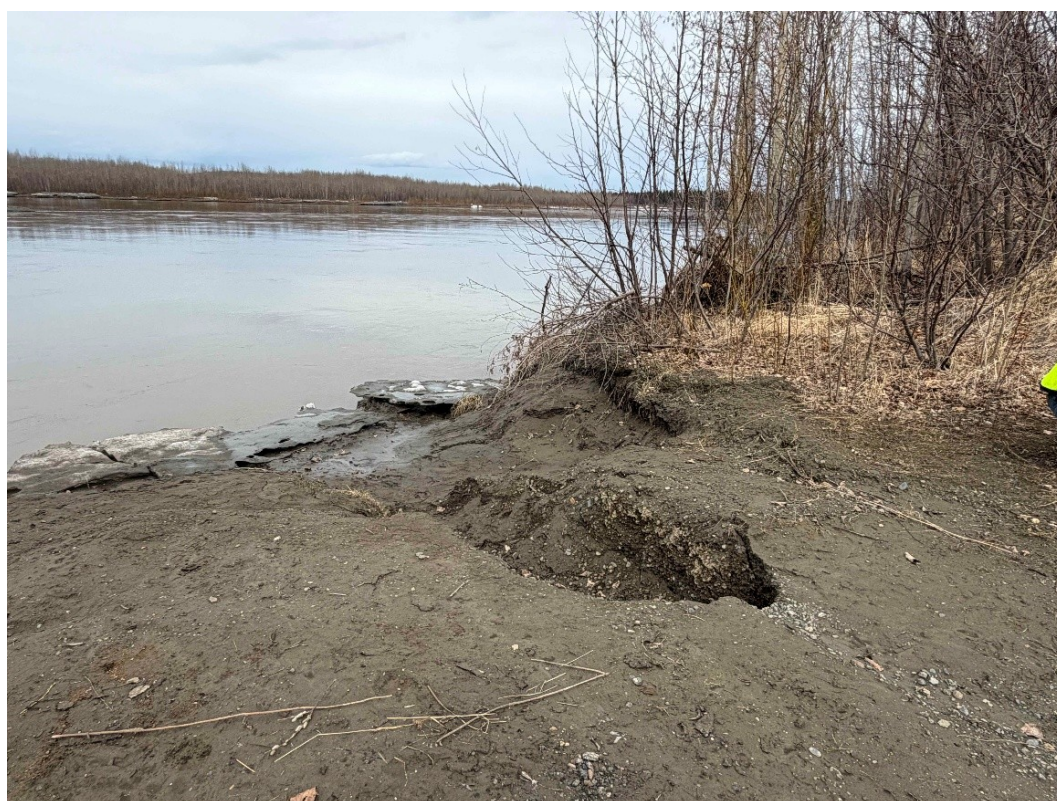
Figure J3. Stony River Site 1 Photos

| HDD BEACH APPROACH SITE GRADING FORM | | |
|---|---|---|
| River Stage | | High water/ Post break up-Water borne ice in the flow, Broken ice on the bank |
| Soil type suitable for HDD | 4 | Material consistent with glacial till/ gravel and sand, Recommend mud products/ Polymers consistent with Running Gravels |

| HDD BEACH APPROACH SITE GRADING FORM | | |
|---|---|---|
| Emergency response / safety access | 4 | Very remote work location, recommend having a local air carrier on call |
| Vault/hut location feasible | Yes | Recommend at nearest pole line. |

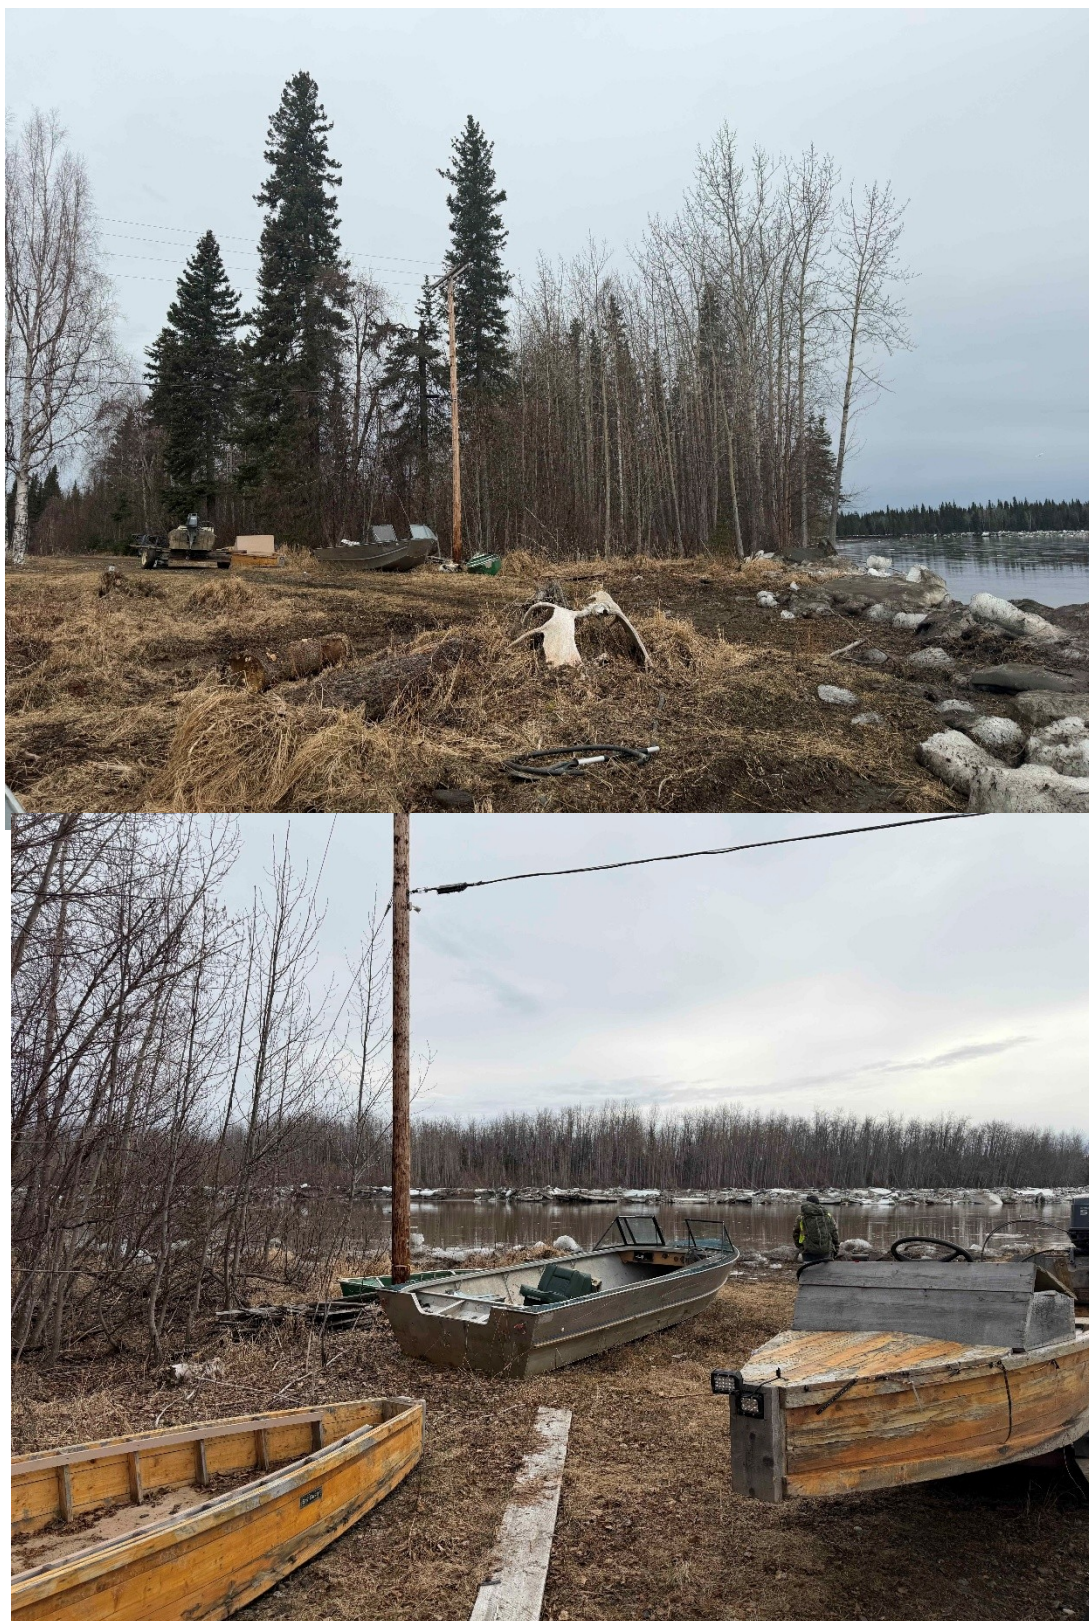
Figure K3. Stony River Site 2 Photos

| HDD BEACH APPROACH SITE GRADING FORM | | |
|---|---|---|
| Soil type suitable for HDD | 5 | Glacial till, Gravel, sand with loamy soil present, recommend mud products consistent with running gravel and clay. |

| HDD BEACH APPROACH SITE GRADING FORM | | |
|---|---|---|
| Distance to fiber hut / vault location | 5 | Hut site recommended at first pole location |
| Emergency response / safety access | 4 | Recommend keeping local carrier flights on call |
