**Kuskokwim River Middle Mile Fiber Technical Feasibility Study  
RD-RU-COOP-25-09**

**Cable Landing Sites Field Report**

Prepared for:  
United States Department of Agriculture  
Rural Utility Service

Prepared by:  
Ayers Telecom Consulting, LLC  
Anchorage, Alaska

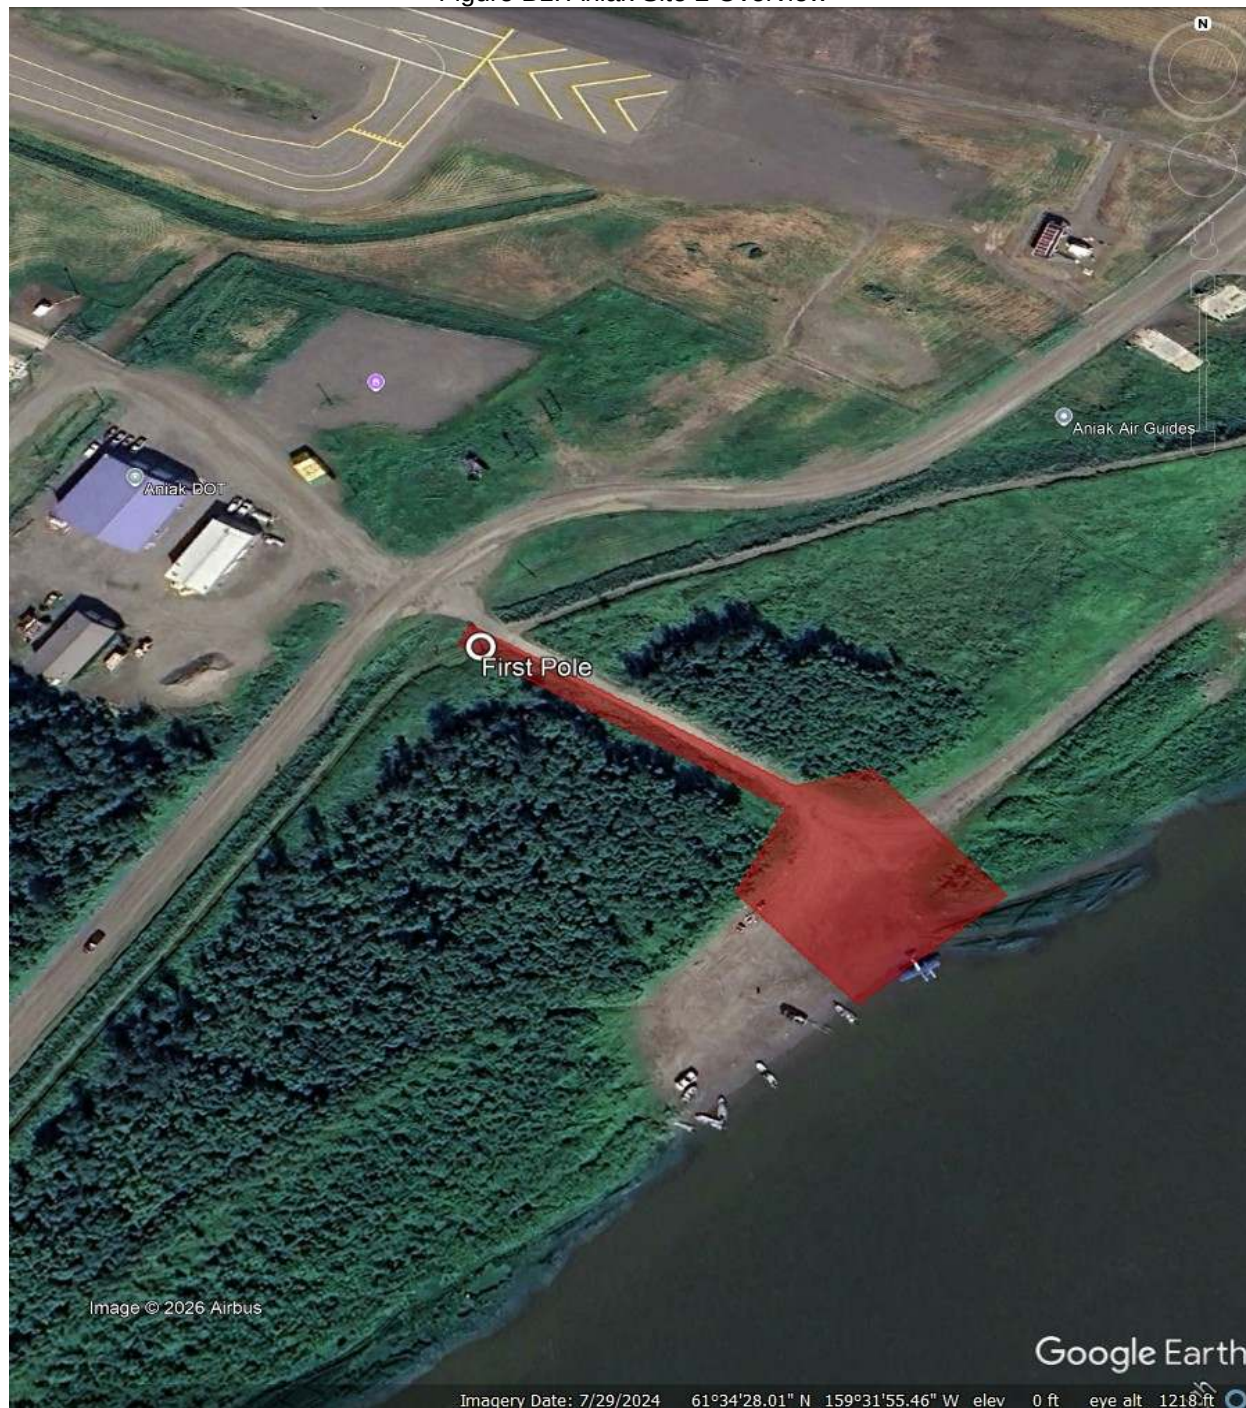
Figure B1. Aniak Site 2 Overview

| HDD BEACH APPROACH SITE GRADING FORM | | |
|---|---|---|
| Evidence of seasonal flooding / ice scour | 3 | Significant ice damage |
| Soil type suitable for HDD | 4 | Soil and Loamy consisten with freshly eroded land, and slough. Low gravel content observed |
| Unstable bank | <input checked="" type="checkbox"/> | Significant erosion observed |

| HDD BEACH APPROACH SITE GRADING FORM | | |
|---|---|---|
| Seasonal water level concern | <input checked="" type="checkbox"/> | Recommend late spring before boring |
| Recommended conduit size/count | | Single 6"SDR 11 HDPE |
| Engineered bore profile and Soundings recommended | | |

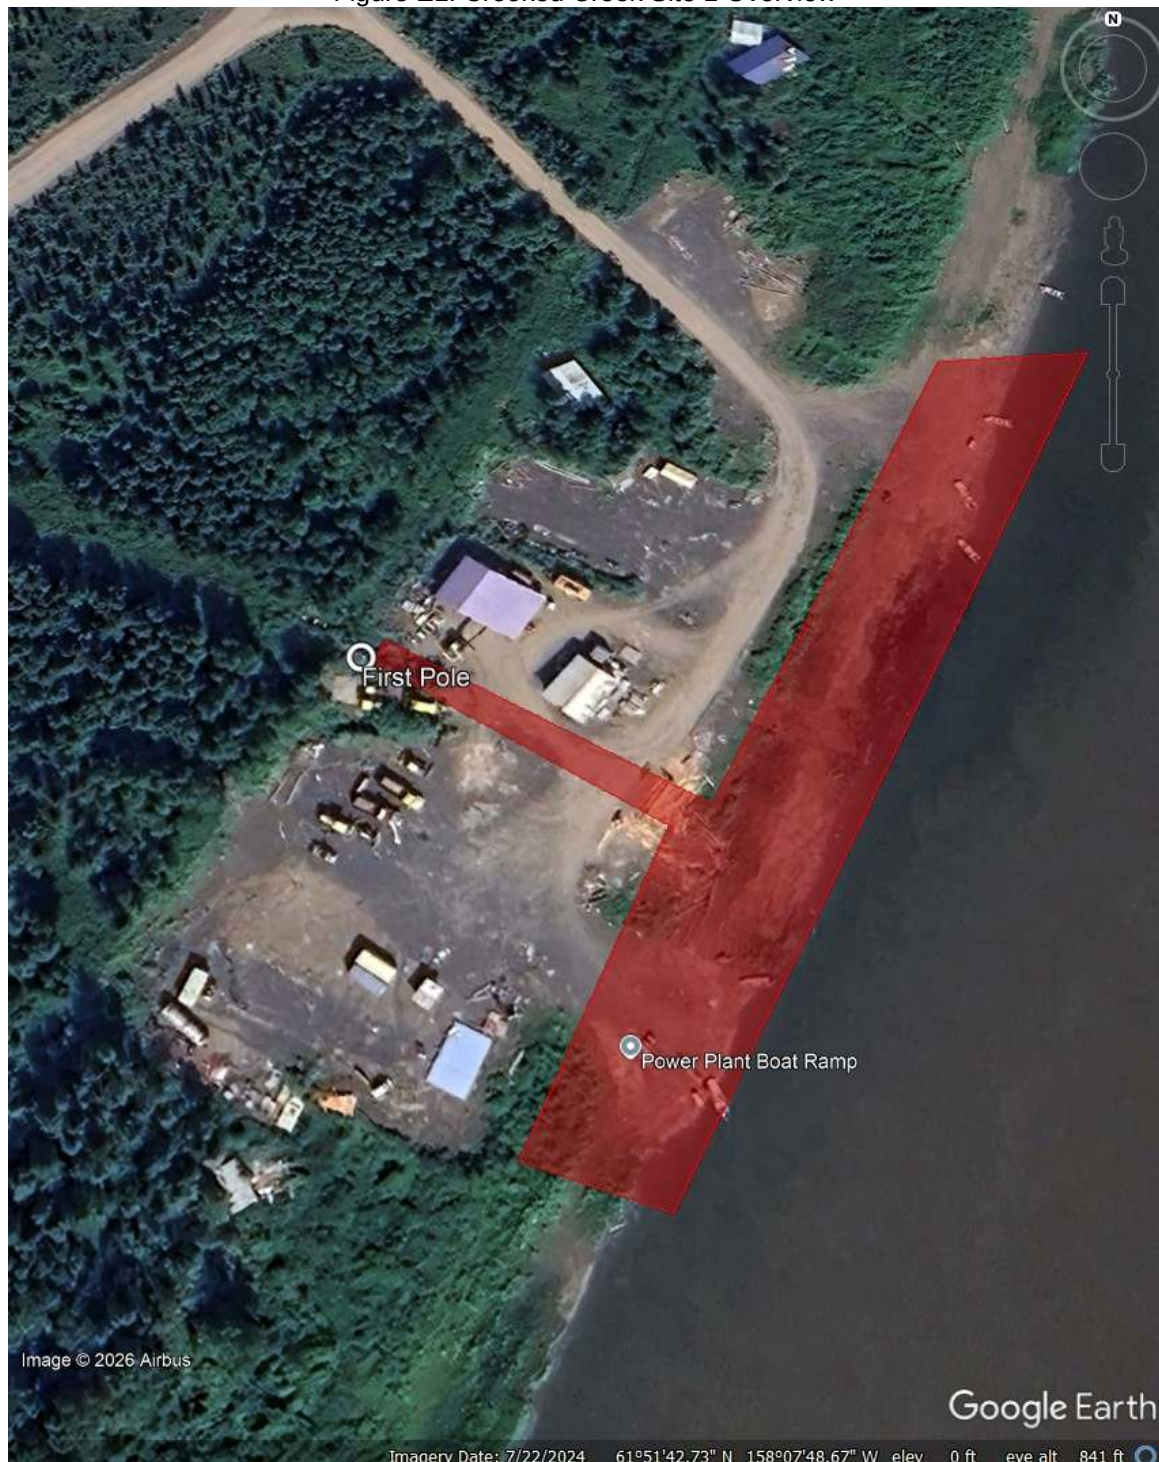
Figure E1. Crooked Creek Site 1 Overview

| HDD BEACH APPROACH SITE GRADING FORM | | |
|---|---|---|
| Soil type suitable for HDD | 3 | Ground conditions suggest Material consistent with River sediment and gravels. However, The greater area has a high likelihood of cobble and potentially rock. |
| Feasible HDD exit location below riverbed | 4 | Conditions unknown, Significant landed ice suggest river has a high volume and speed of flow. This may just be seasonal |

| HDD BEACH APPROACH SITE GRADING FORM | | |
|---|---|---|
| Recommended conduit size/count | | Single 6" SDR11 HDPE |

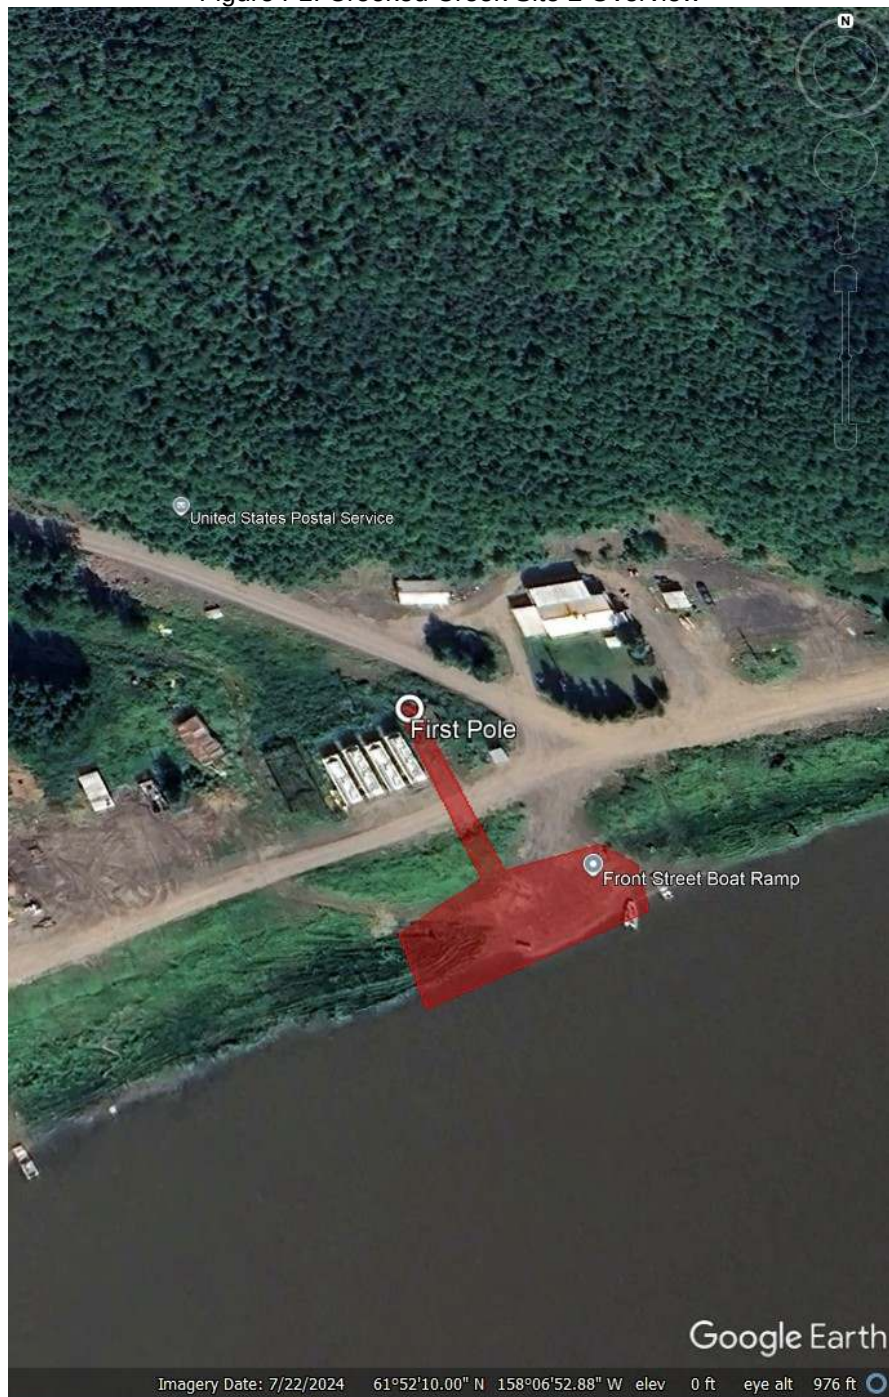
Figure F1. Crooked Creek Site 2 Overview

| HDD BEACH APPROACH SITE GRADING FORM | | |
|---|---|---|
| Soil type suitable for HDD | 3 | Ground conditions suggest Material consistent with River sediment and gravels. However, The greater area has a high likelihood of cobble and potentially rock. |
| Feasible HDD exit location below riverbed | 4 | Conditions unknown, Significant landed ice suggest river has a high volume and speed of flow. This may just be seasonal |

| HDD BEACH APPROACH SITE GRADING FORM | | |
|---|---|---|
| Recommended conduit size/count | | Single 6" SDR11 HDPE |

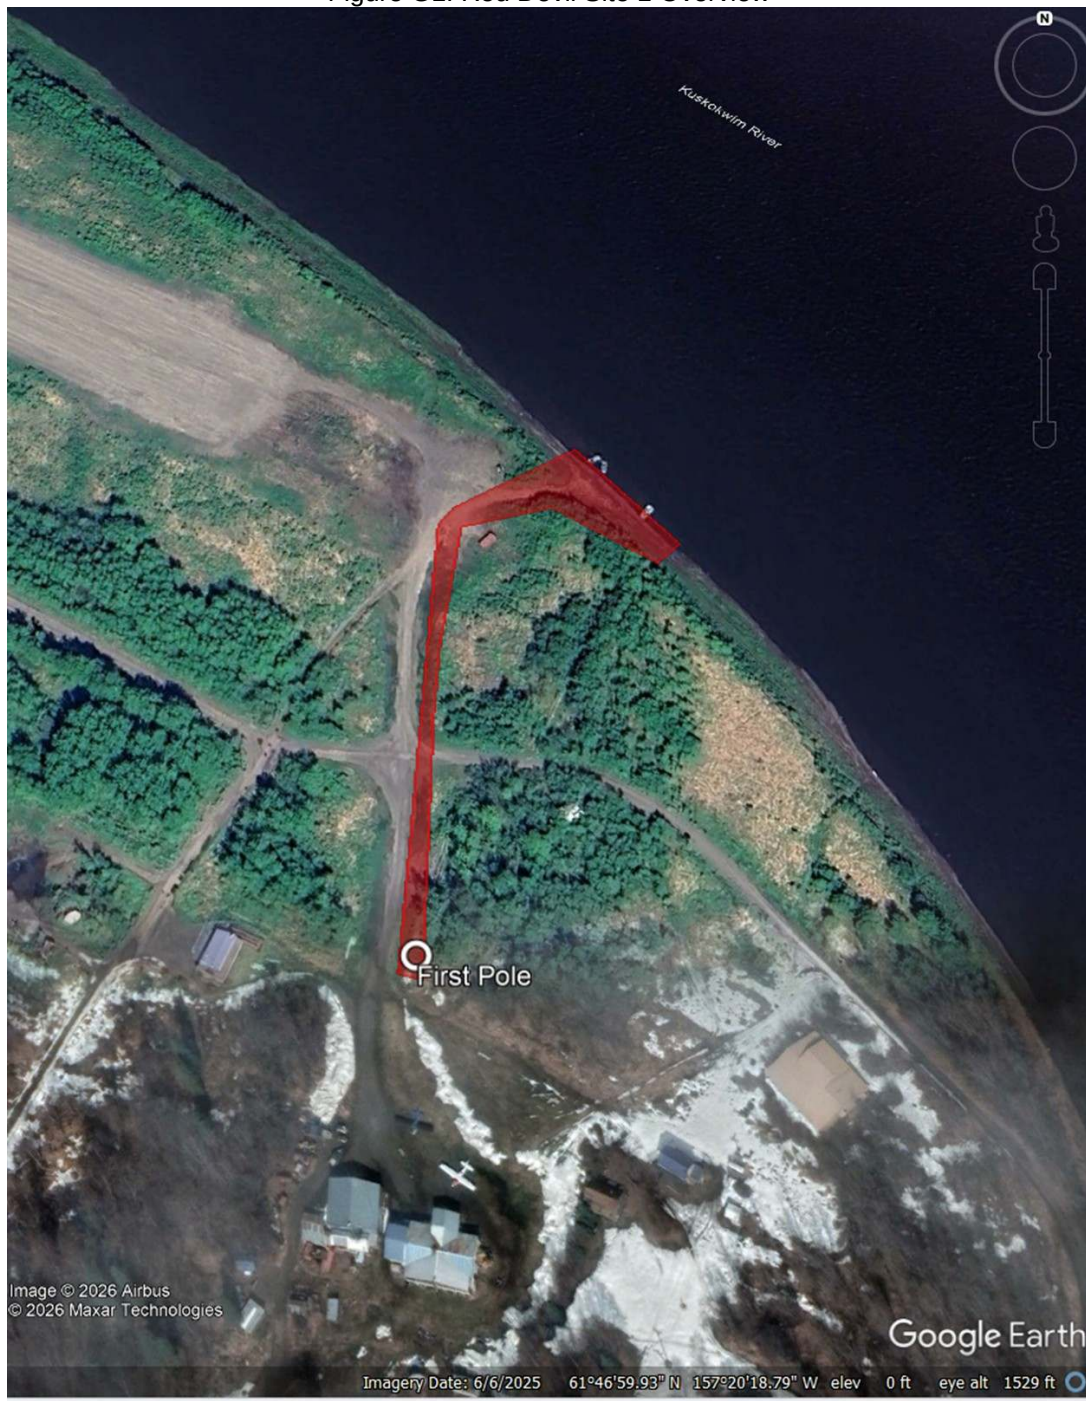
Figure G1. Red Devil Site 1 Overview

| HDD BEACH APPROACH SITE GRADING FORM | | |
|---|---|---|
| Cobbles / boulders / bedrock risk | 5 | None observed either on site or flyover |

| HDD BEACH APPROACH SITE GRADING FORM | | |
|---|---|---|
| Mud handling / containment area | 4 | Proximity to river and slope to beach/ recommendd BMPs |
| Distance to fiber hut / vault location | 3 | Due to active runway constraints recommend vault at beach with hut near first pole |
| Emergency response / safety access | 4 | Recommend local carrier on call |
| Recommended conduit size/count | | 6" SDR11 HDPE |

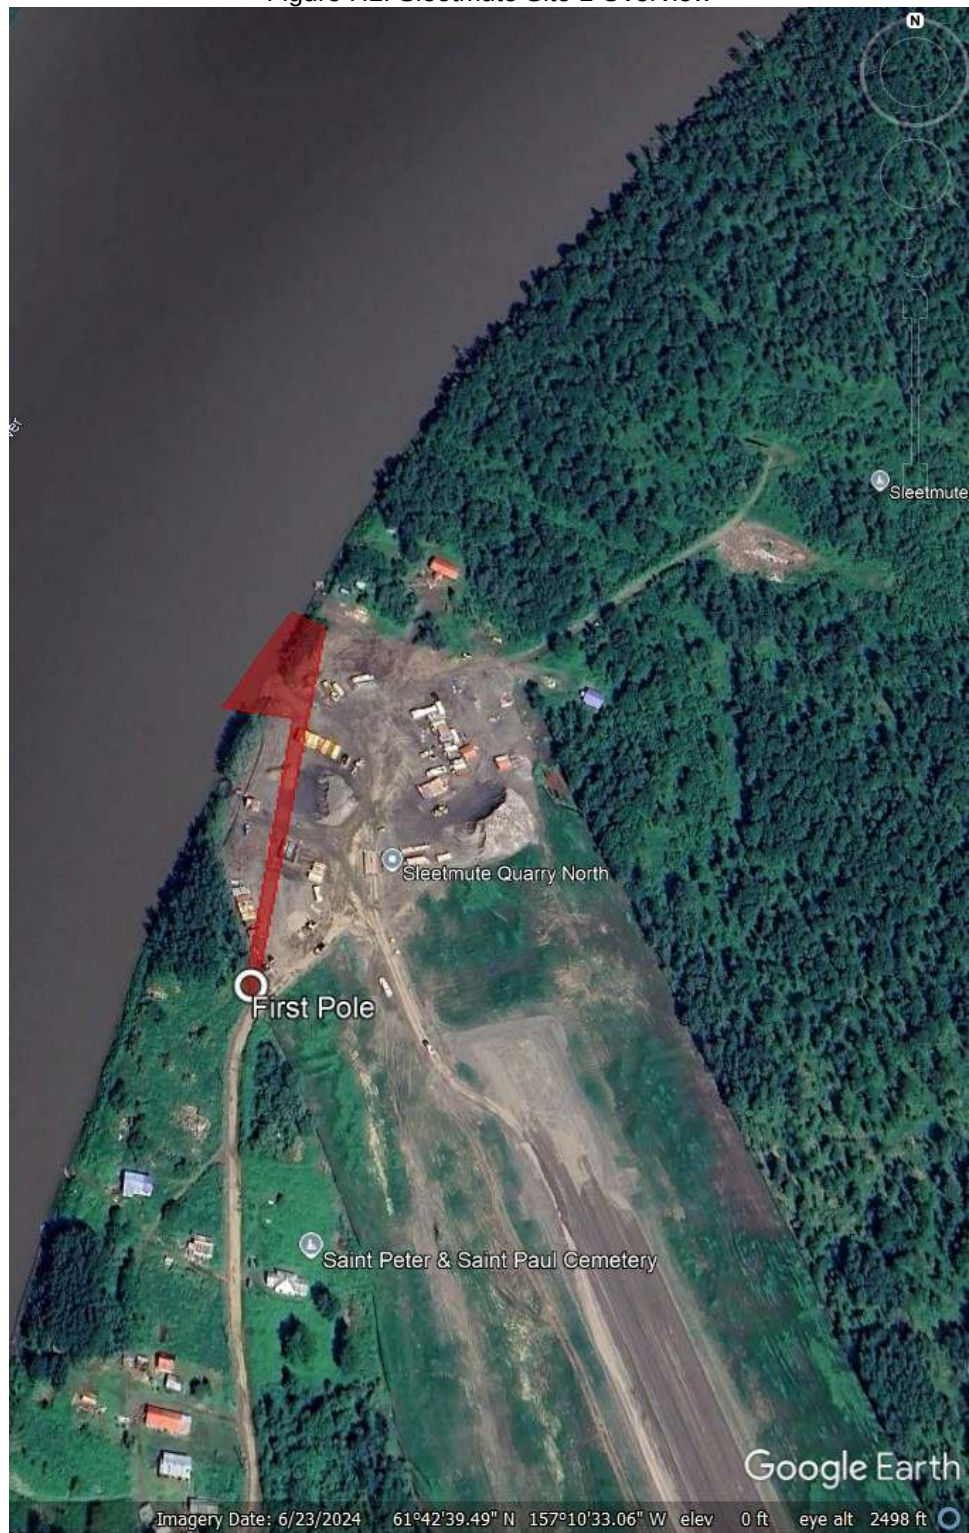
Figure H1. Sleetmute Site 1 Overview

| HDD BEACH APPROACH SITE GRADING FORM | | |
|---|---|---|
| Cobbles / boulders / bedrock risk | 4 | None observed |
| Distance to fiber hut / vault location | 2 | 500' plus to first pole. Hut site could be closer but recommend placement of the hut outside active quarry area |

| HDD BEACH APPROACH SITE GRADING FORM | | |
|---|---|---|
| Seasonal water level concern | <input checked="" type="checkbox"/> | Recommend mid to late summer due to high flow water |
| Recommended conduit size/count | | single 6" SDR11 HDPE Conduit (Recommend welded sticks not roll pipe) |

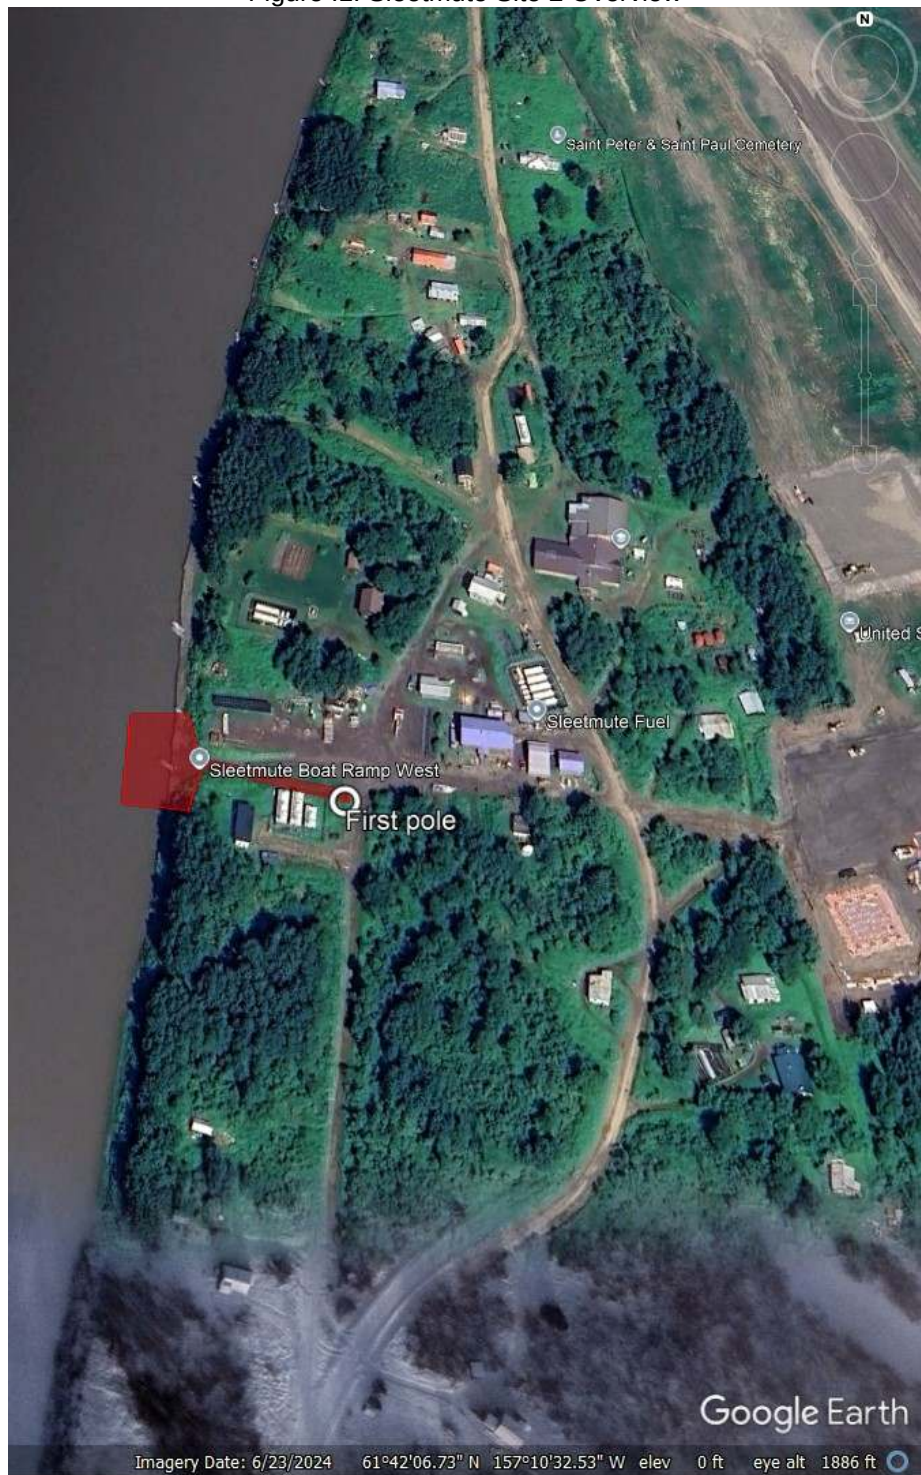
Figure I1. Sleetmute Site 2 Overview

| HDD BEACH APPROACH SITE GRADING FORM | | |
|---|---|---|
| Cobbles / boulders / bedrock risk | 4 | None observed |

| HDD BEACH APPROACH SITE GRADING FORM | | |
|---|---|---|
| Seasonal water level concern | <input type="checkbox"/> X | Recommend mid to late summer due to high flow water |
| Recommended conduit size/count | | single 6" SDR11 HDPE Conduit (Recommend welded sticks not roll pipe) |

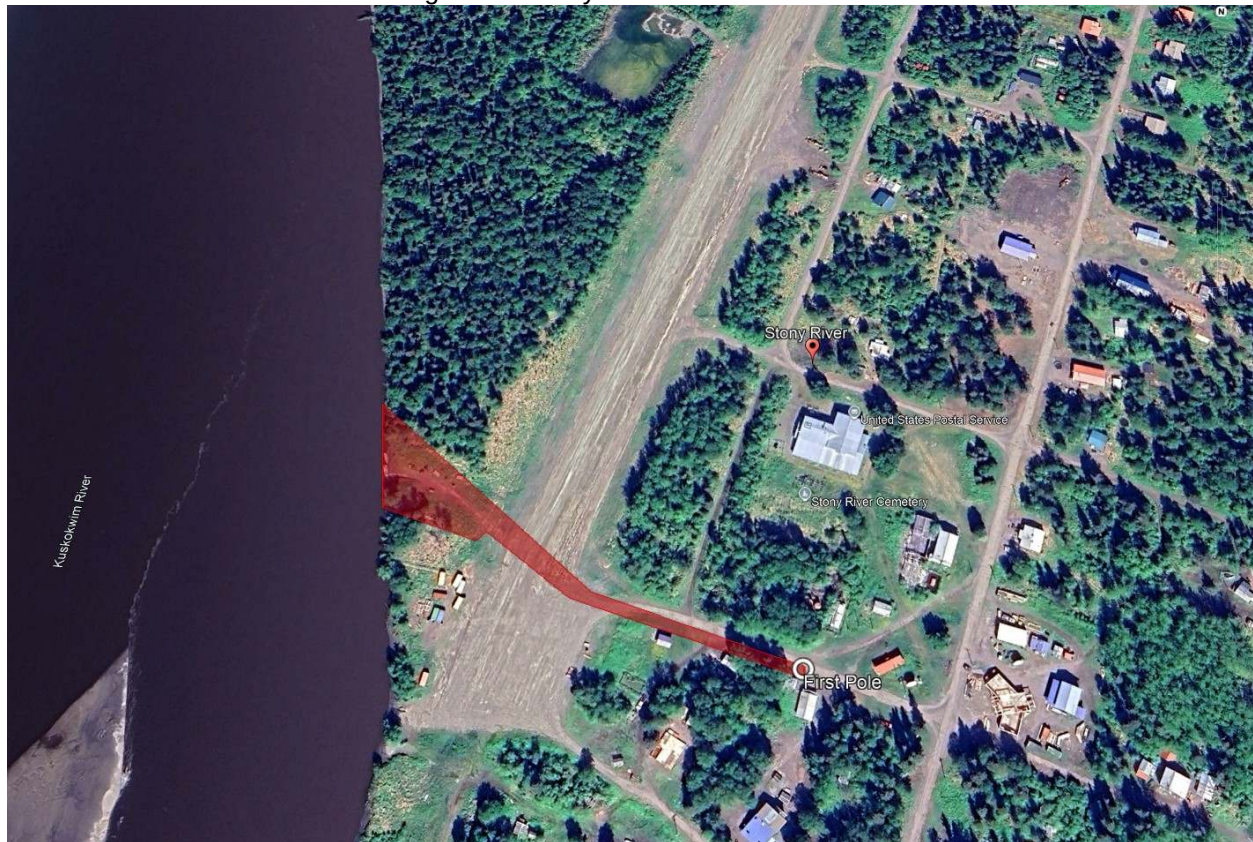
Figure J1. Stony River Site 1 Overview

| HDD BEACH APPROACH SITE GRADING FORM | | |
|---|---|---|
| River Stage | | High water/ Post break up-Water borne ice in the flow, Broken ice on the bank |
| Soil type suitable for HDD | 4 | Material consistent with glacial till/ gravel and sand, Recommend mud products/ Polymers consistent with Running Gravels |
